Continuous monitoring of pump performance – case studies

Pump Industry Australia seminar, Melbourne, 27 April 2017

“How to get the best out of your pumps?”

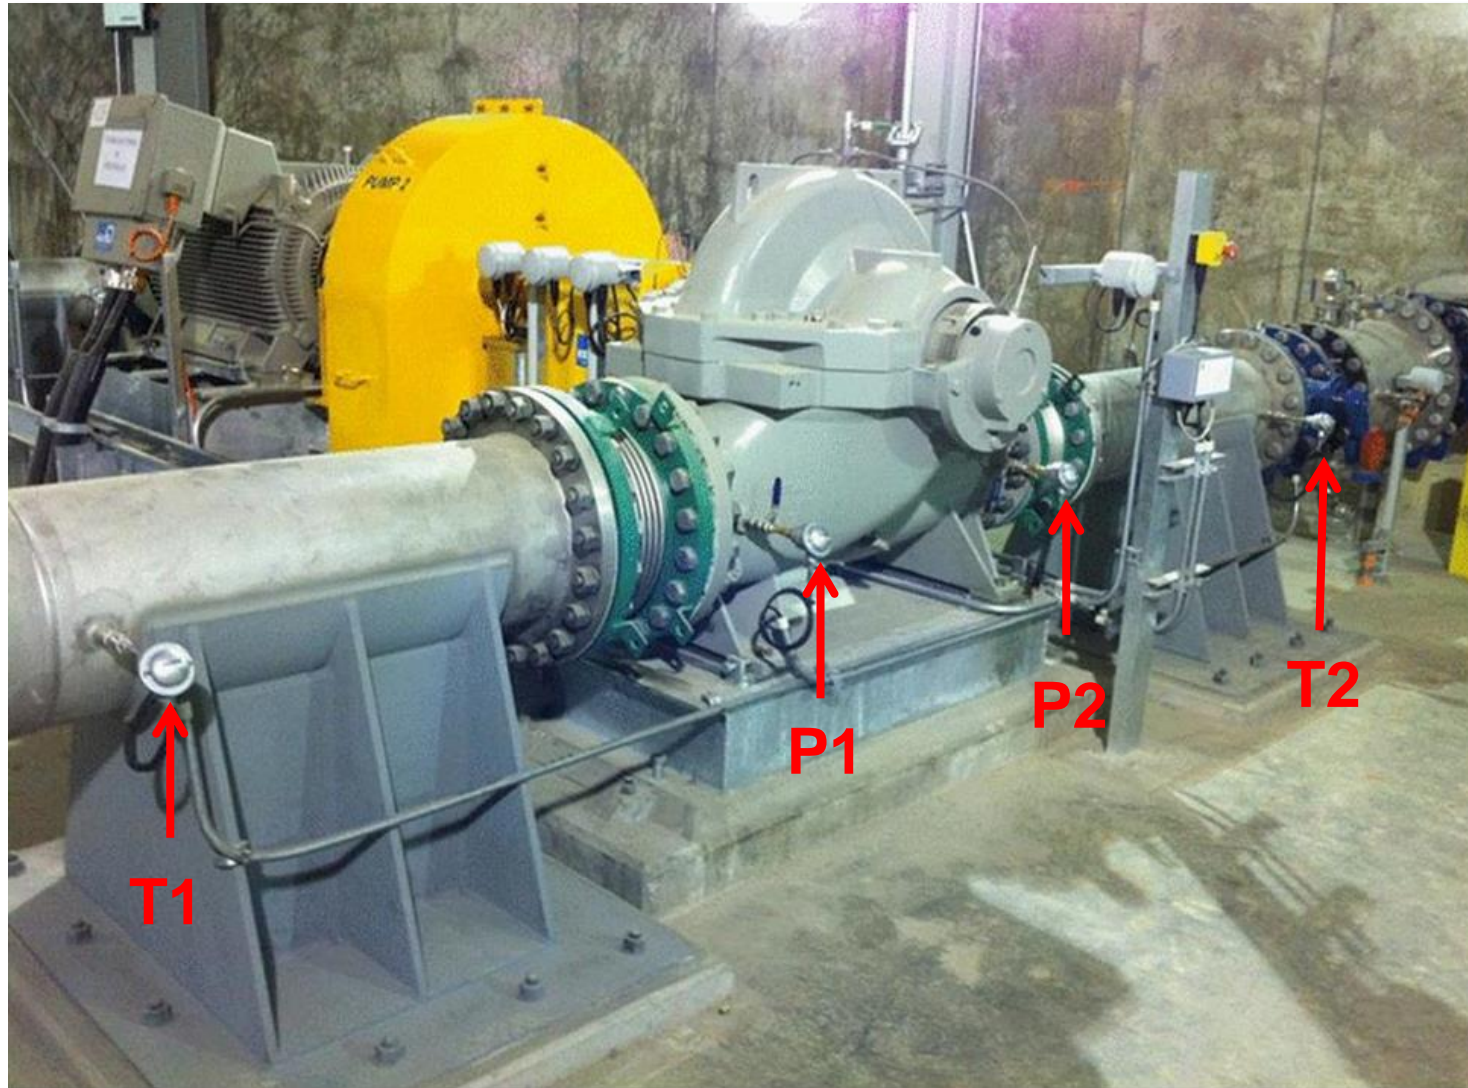
Typical locations for temperature and pressure probes

- T1 – suction temperature
- T2 – discharge temperature
- P1 – suction pressure
- P2 – discharge pressure

Also measured

- Electrical power to motor
- Motor speed (for variable speed drives)
- Delivery manifold pressure P3

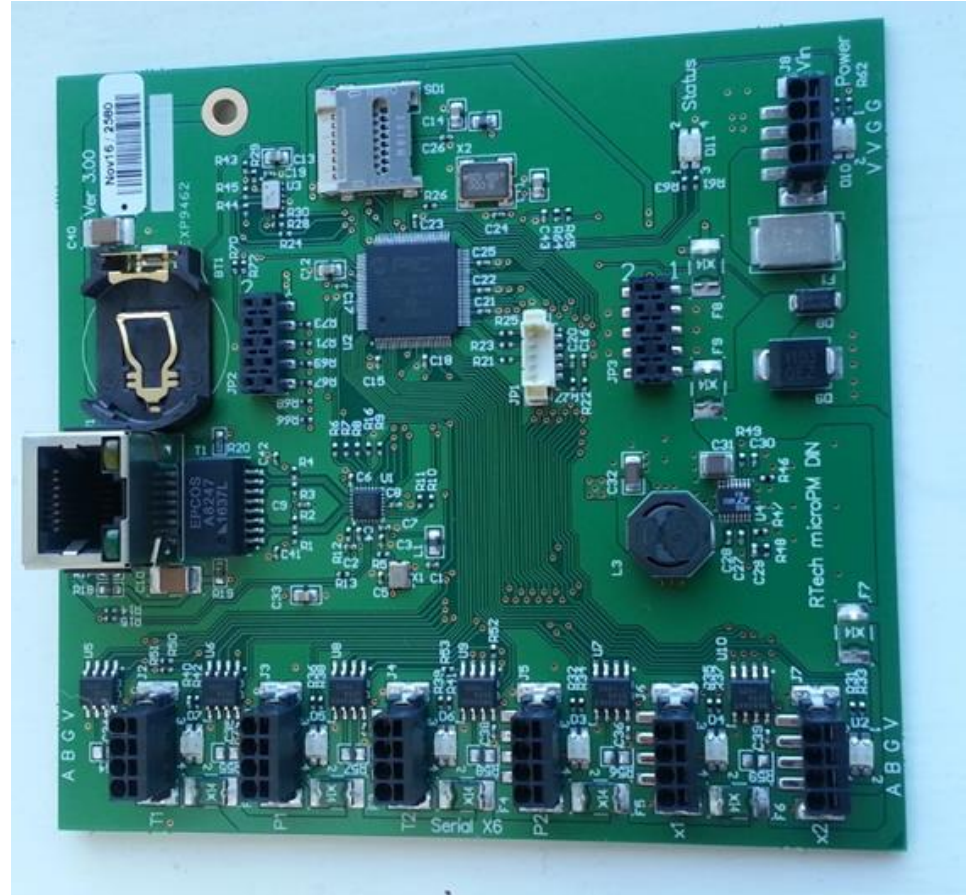
Expert firmware within a microprocessor

- Sensor data analysed on-board
- Connects via Ethernet, with TCP Modbus protocol
- Embedded webpages for initial set-up and configuration
- Information held in specific registers
- Live data monitoring and self-testing
- Minimal SCADA / HMI development and maintenance costs
- DIN rail mounting

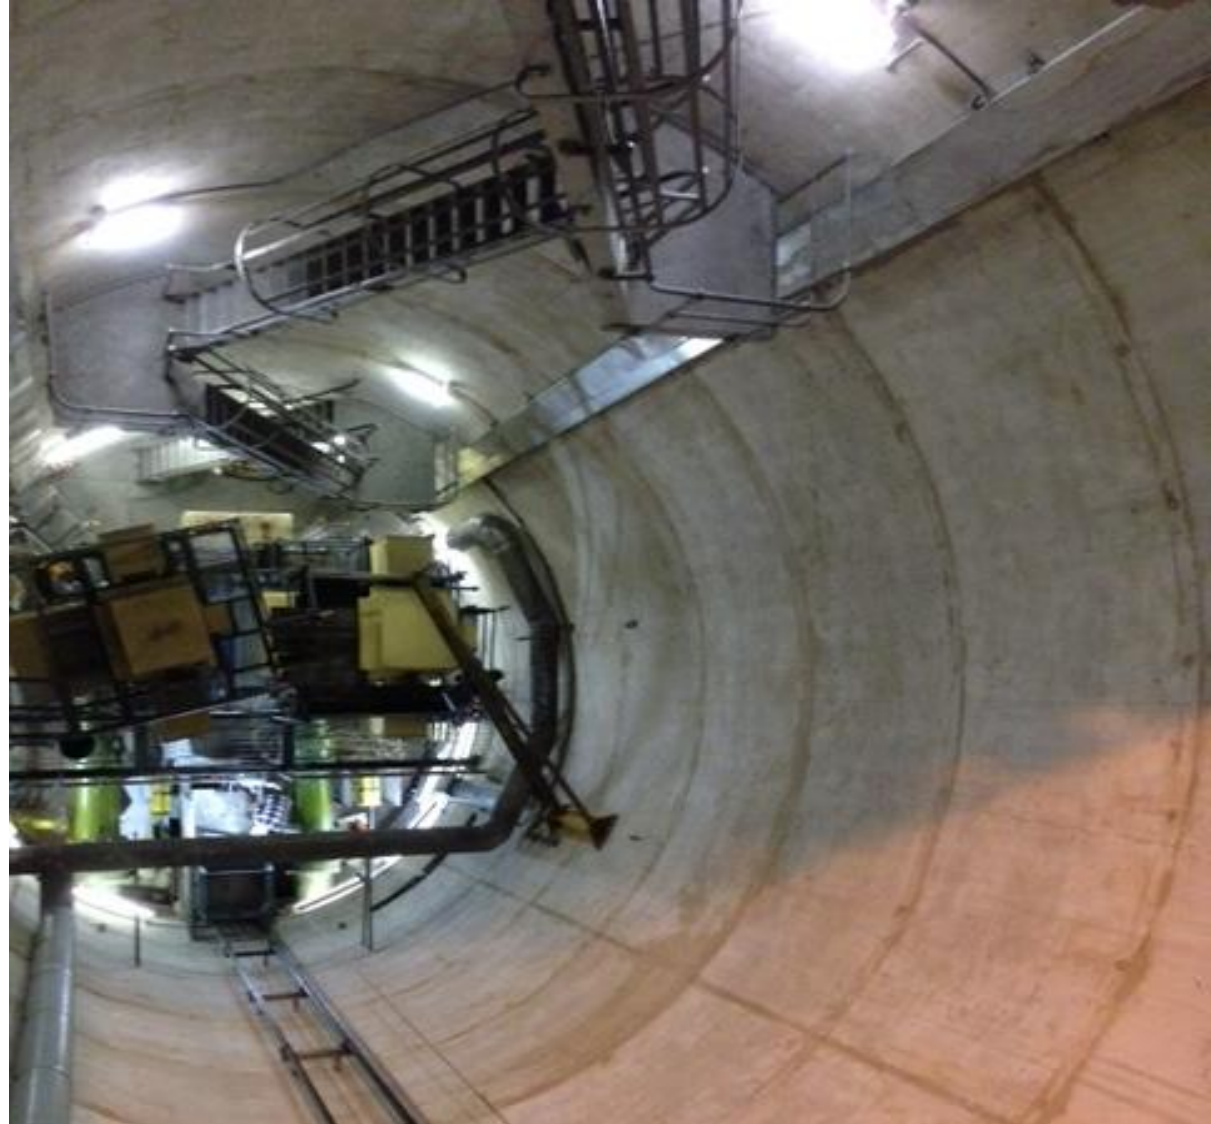
Two 3 MW pumps at bottom of 40 m deep pit

Provide cooling water to power station

Pump condition monitored by SCADA, with alert levels

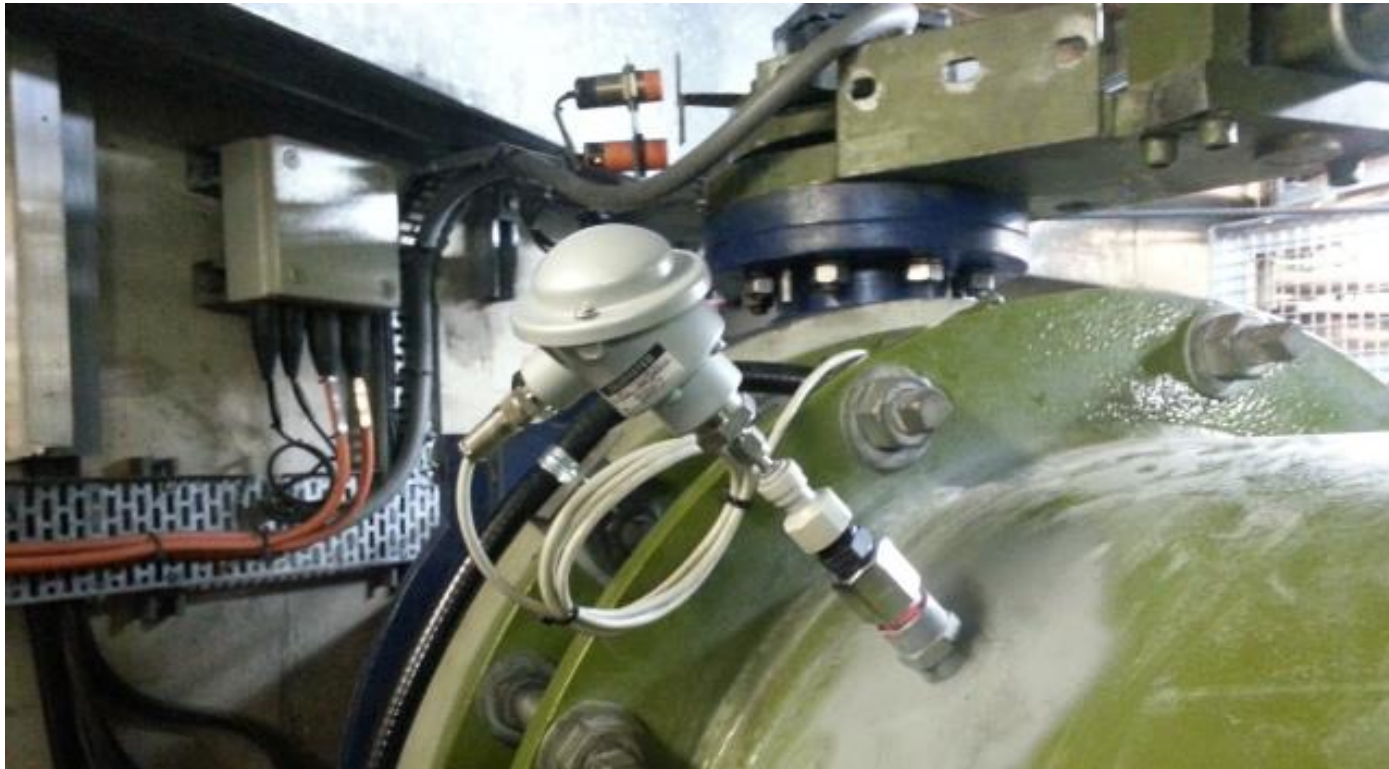
Temperature probes are inserted via low mass thermowells

Minimises vibration heating, mechanical stress, and stem effect

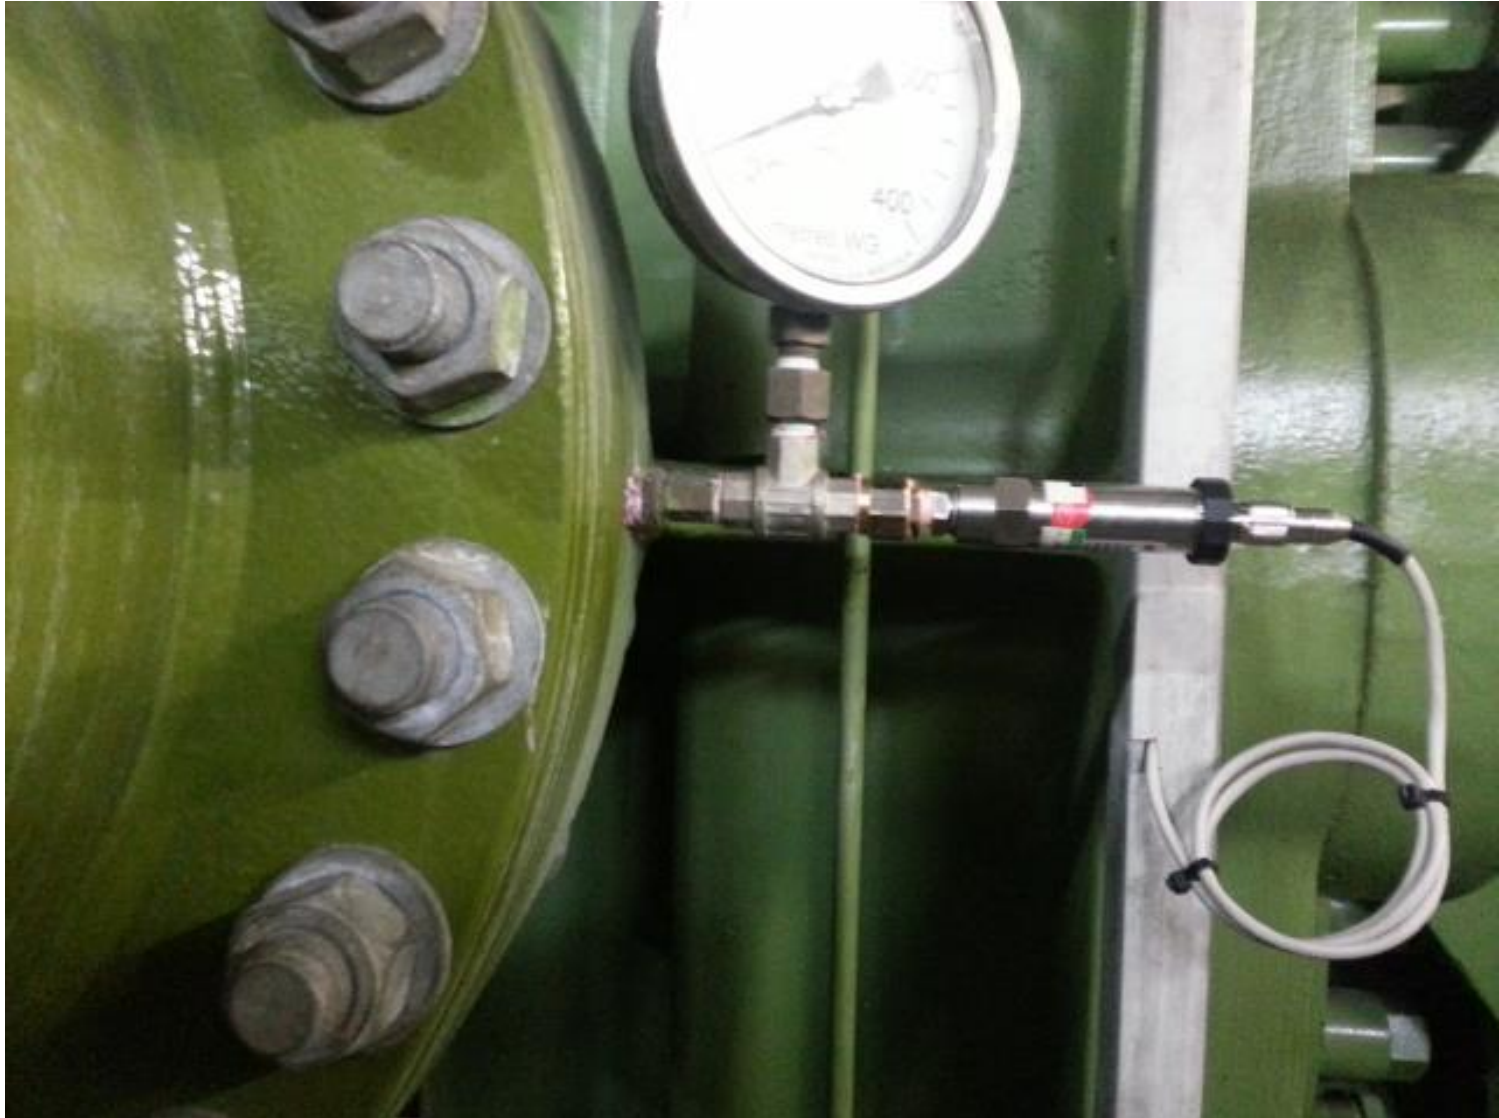
Pressure probe teed off from existing analogue meter

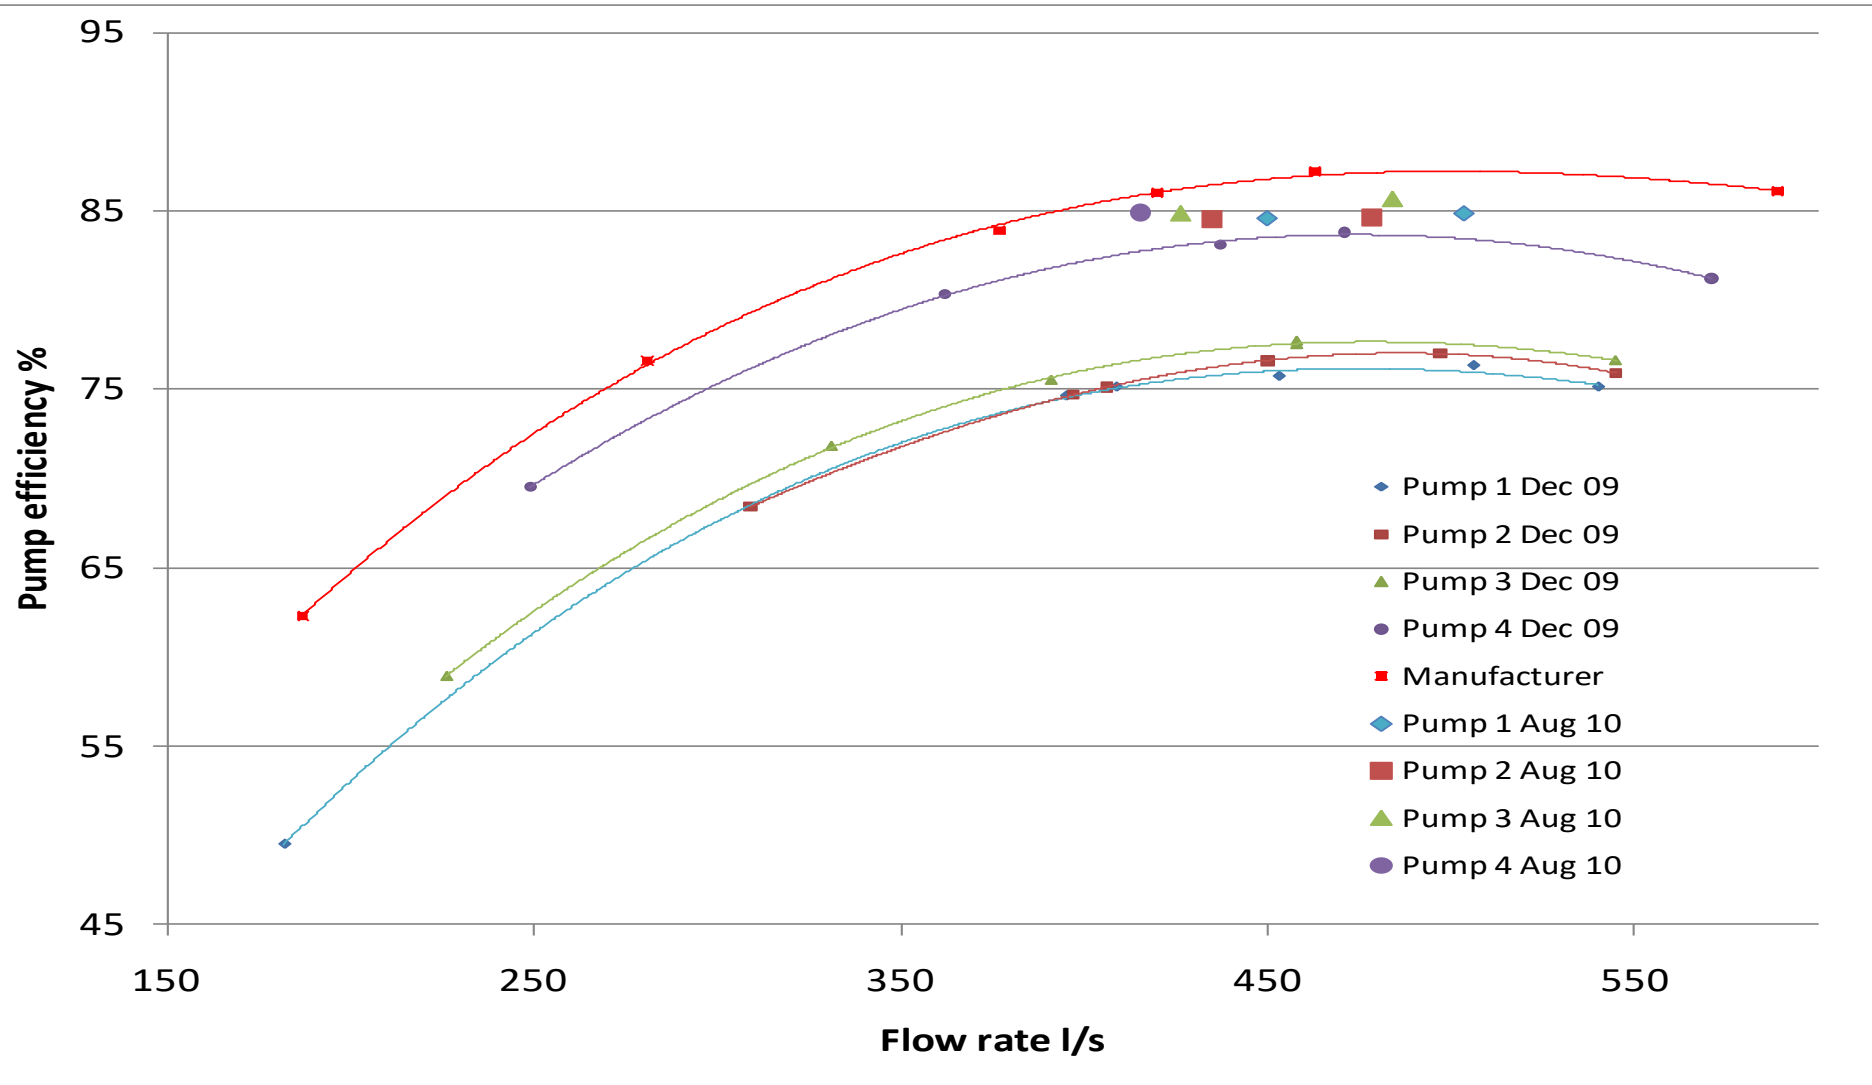
Rapid deterioration in pump efficiency

– 10 months to detect the problem

The same problem has occurred twice more since then. The cost of continuous monitoring would be quickly recouped.

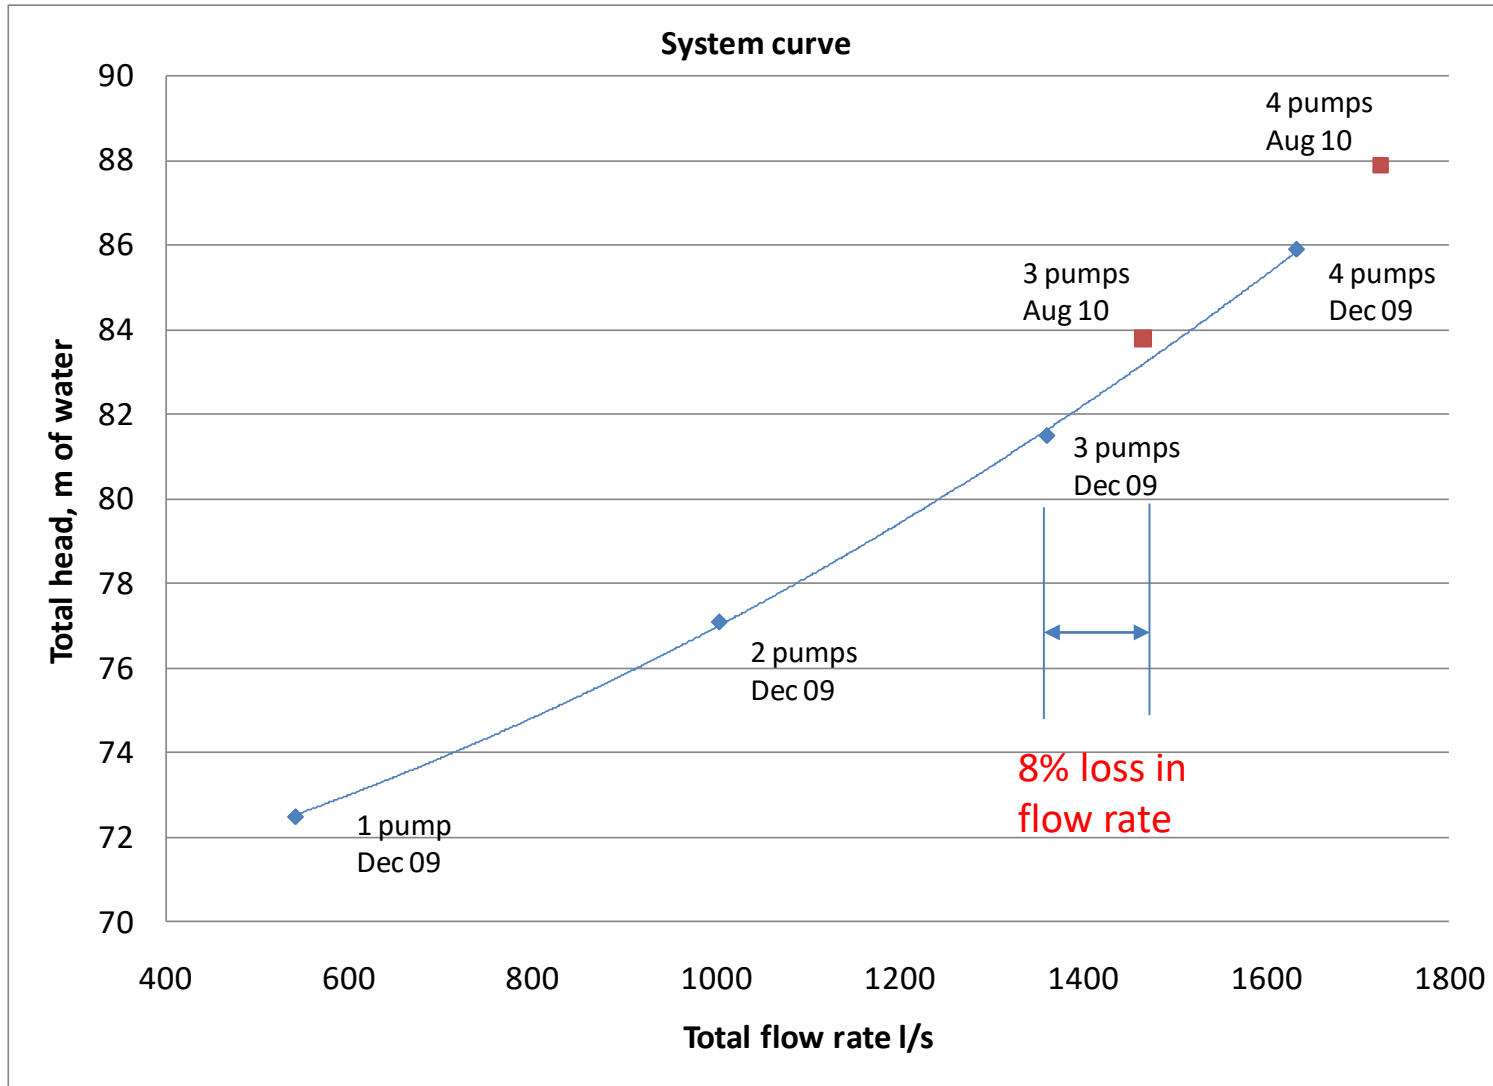
Resultant loss in flow rate
